**FOCUSED SITE INSPECTION PRIORITIZATION
SITE EVALUATION REPORT**

**SERVICE DISPOSAL NO. 1
JUNCTION STATE ROUTE 316 AND LOXA ROAD
MATTOON, ILLINOIS**

CERCLIS ID NO.: ILD980901433

Date Prepared: September 29, 1995
U.S. EPA Region: 5
Contract No.: 68-W0-0037
Technical Direction Document No.: T05-9503-230
Prepared by: Ecology and Environment, Inc.
Chad Eich
E & E Program Leader: Steven Skare
Telephone No.: (312) 663-9415

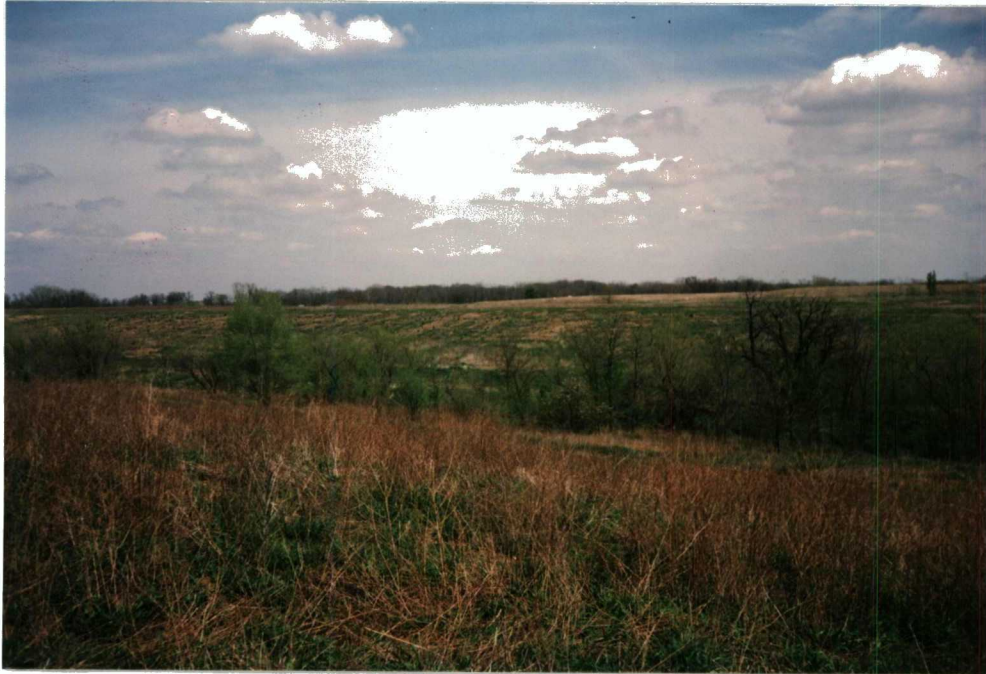
Photo 1 Date: 4/24/95 Time: 1:18 Direction: E
 Site Name: Service Disposal #1
 Comments: Vegetated eastern and western fill areas

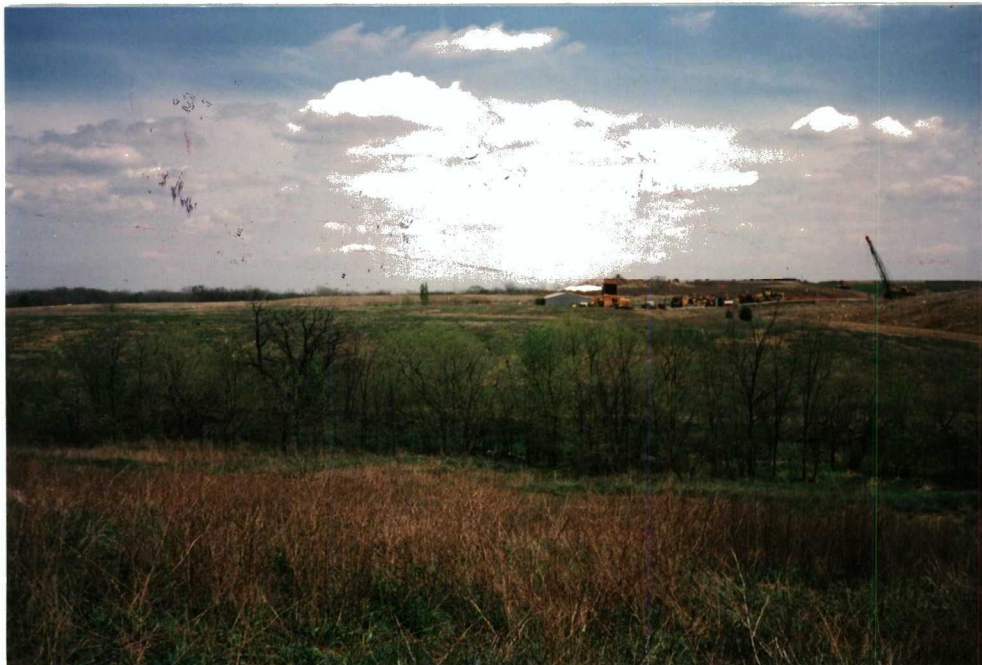
Photo 2 Date: 4/24/95 Time: 1:17 Direction: E
 Site Name: Service Disposal #1
 Comments: View of eastern fill area from western fill area. Far right shows a current active western lion landfill area, south of dirt road.

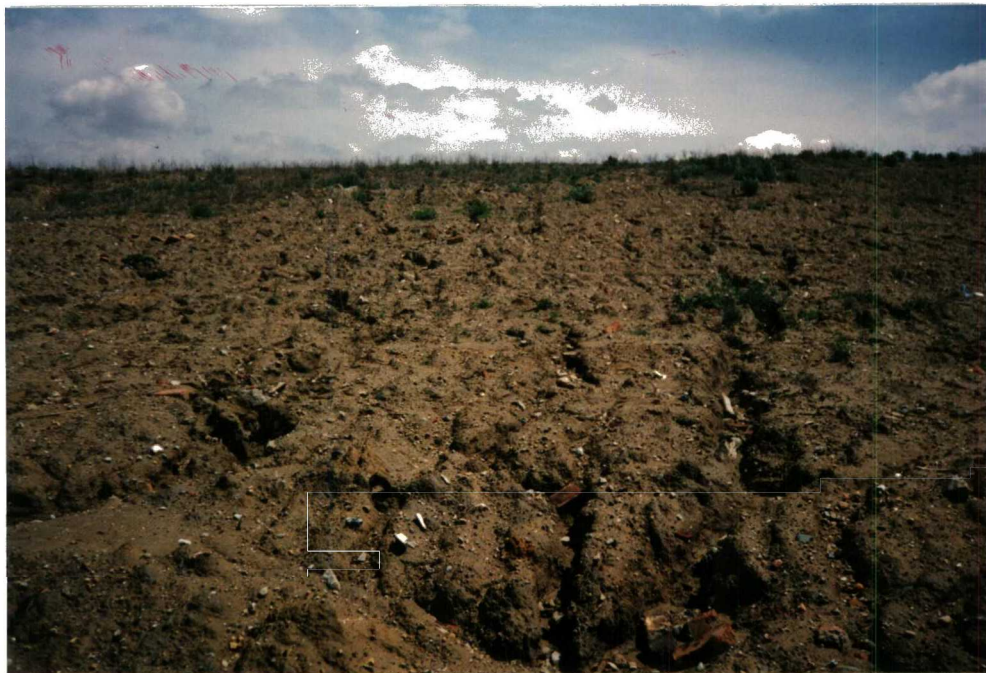
Photo 3 Date: 4/24/95 Time: 1:15 Direction: E
 Site Name: Service Disposal #1
 Comments: Erosion gullies on western side of eastern fill area. Some exposed wastes protruding from the cover material.

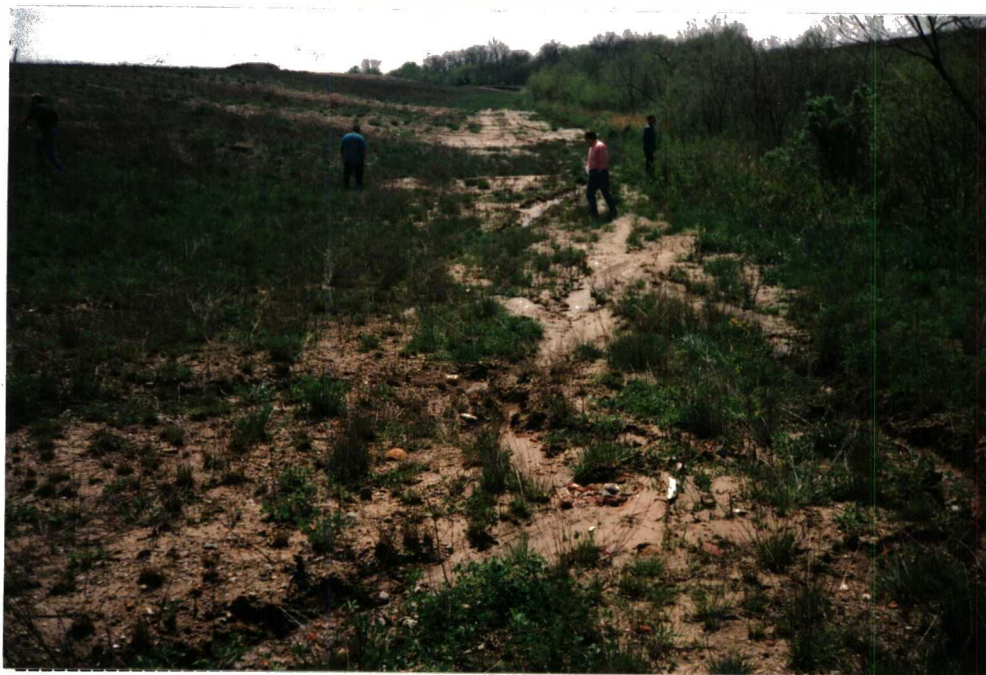
Photo 4 Date: 4/24/95 Time: 1:35 Direction: S
 Site Name: Service Disposal #1
 Comments: View of western boundary of eastern disposal area with Riley Creek. Note leachate seeps along erosional gullies

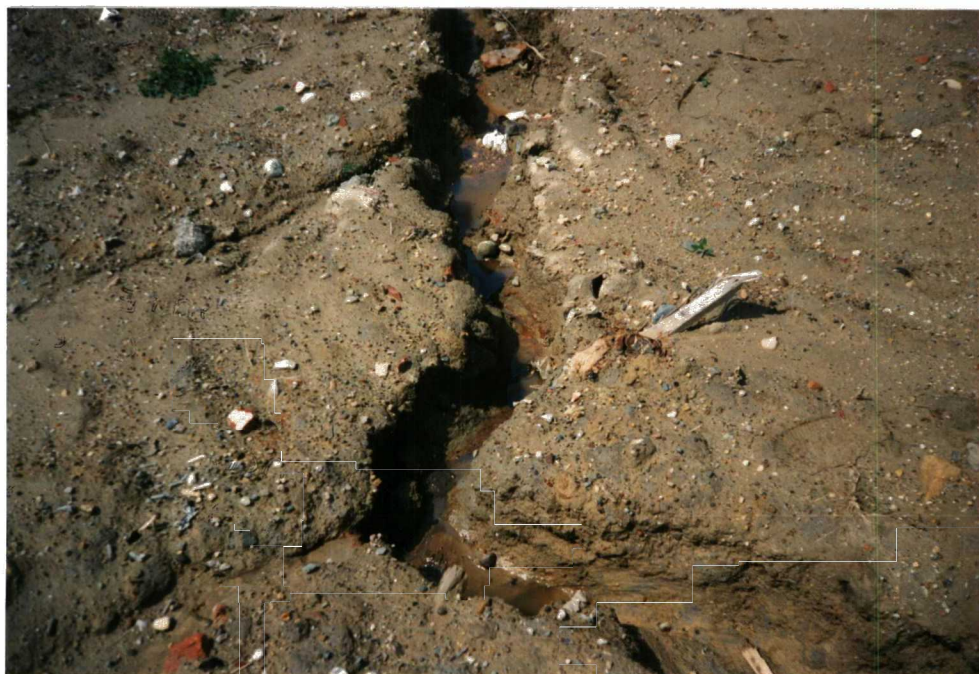
Photo 5 Date: 4/24/95 Time: 1:30 Direction: W
 Site Name: Service Disposal #1
 Comments: Erosion gully on western side of eastern fill
 area, flowing toward Riley Creek. Note
 leachate discolored soils and exposed debris.

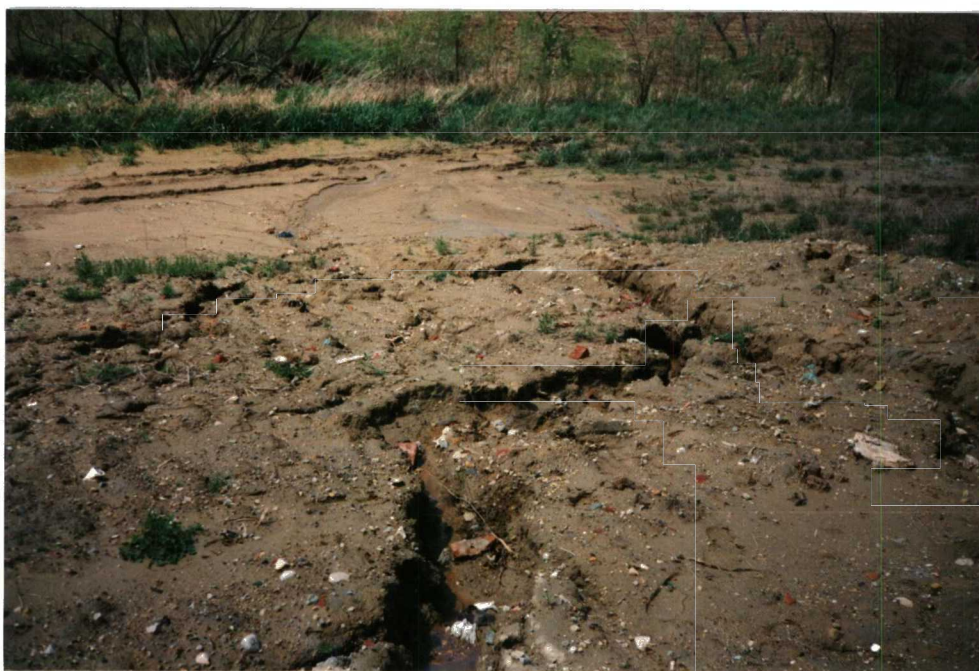
Photo 6 Date: 4/24/95 Time: 1:30 Direction: W
 Site Name: Service Disposal #1
 Comments: View of erosion gully containing leachate,
 flowing toward level area and Riley Creek

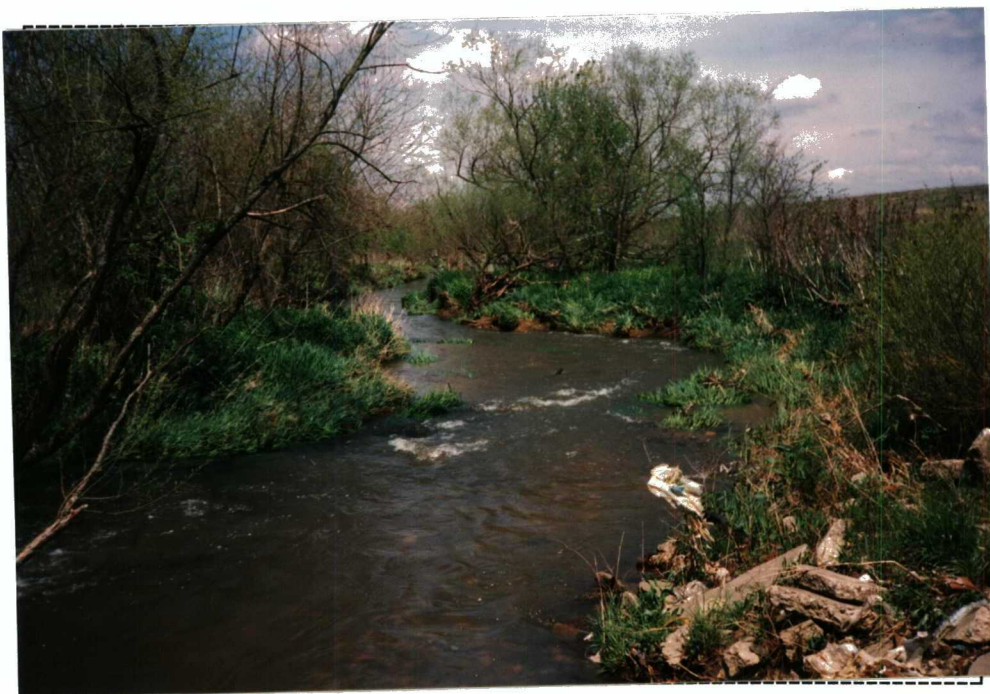
Photo 7 Date: 4/24/95 Time: 1:20 Direction: N
Site Name: Service Disposal #1
Comments: View of Riley Creek. Riley Creek flows on-site at this point.
